**Flood Control Project Maintenance
Levee Inspections**

Maintenance Issue Types Only, Levee Inspection Report By Mile - Spring 2020

Sacramento Maintenance Yard Willow Slough Bypass

Waterway	Bank	Unit Miles	Inspection Start/End	Inspector
Unit No. 01 Willow Slough Bypass or North Levee	Left	5.05	04/07/2020 04/07/2020	Zach Jojola

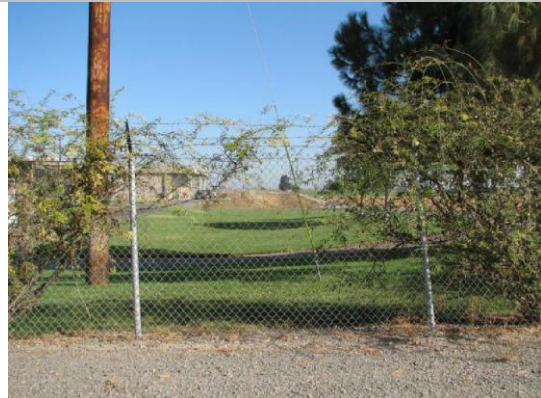
Photo 1 of 3 : UCIP_SP_2020_44903_22882.jpg

Comment Code						
Inspector Comment						
DS_ID:17834 FS_ID:44903 EP_NO: 10130 Repair Type: No Action Needed Crossing Status: Found UCIP Comments: 01/08/2019 Received updated permit information for this crossing from D. Biswas with the CVFPB. The structure description has been updated with the correct abandonment permit information. (O. Magana - DWR UCIP) 05/02/2017 CVFPB Letter sent April 12, 2012 regarding Permit #10130 - Internal Inspections of Pipes Crossing State Plan of Flood Control Levee. Permit No. 10130 previously referenced in UCIP record was removed--permit does not reference 36-inch pipe. (O. Magana - DWR UCIP) 04/12/2017 Mud/debris on WS removed by JK, RF. (C. Lund - DWR Sacramento Yard) 05/05/2015 Removed debris from the outlet. (C. Lund - DWR Sacramento Yard) 09/19/2012 Minor debris blocking flap gate. Debris/log needs to be removed from the outlet. (P. Amatya - DWR UCIP) FIELD_STRUCT_DESC: 36-inch corrugated metal drainage pipe through the levee, 18 feet below the crown. Flap gate is located on the waterside (WS) end. (no permit was found authorizing 36-inch pipe [pipe is referenced in O&M Manual, Station 271+54]; 36-inch was authorized for abandonment under Permit No. 12789-1, 2018 - City of Davis) [Additional Reference(s): USACE Sacramento O&M Manual Unit 120, Willow Slough Channel Relocation and Levee Construction, February 1947, Drawing No. 50-4-2281 Sheet 4 (Station 271+54)] FS Date: 5/5/2015 8:02:11 AM

Landside view- beyond grass area see drainage inlet

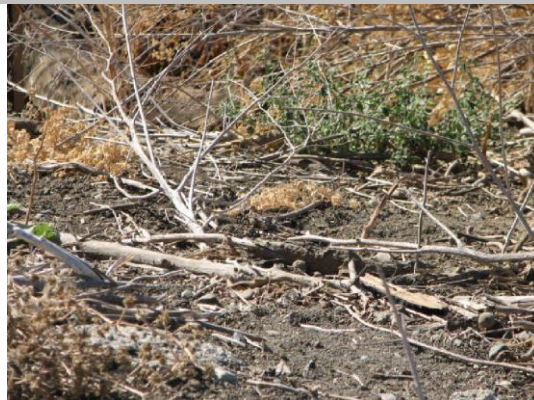
Photo 2 of 3 : UCIP_SP_2020_44903_22881.jpg

Waterside view- general view

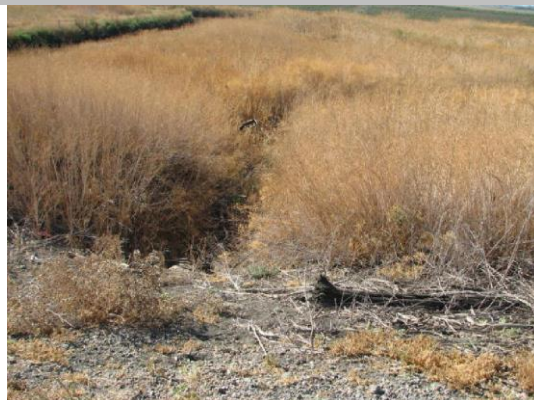
Photo 3 of 3 : UCIP_SP_2020_44903_22880.jpg

Waterside overview. Notice waterway.

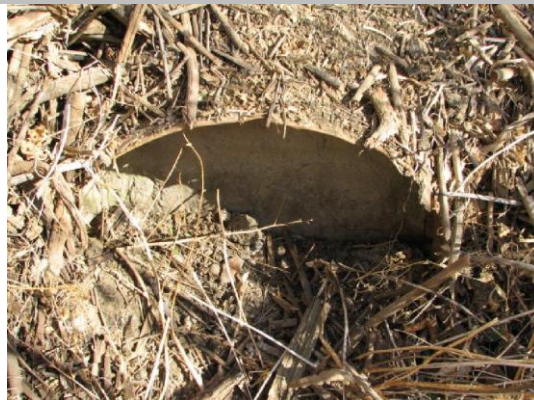
Photo 1 of 3 : UCIP_SP_2020_44904_22885.jpg

Comment Code						
Inspector Comment						
DS_ID:17613 FS_ID:44904 EP_NO: 10309 Repair Type: No Action Needed Crossing Status: Found UCIP Comments: 09/19/2012 Abandoned in place. CMP filled with concrete. (DWR UCIP - P. Amatya) FIELD_STRUCT_DESC: 30-inch steel drainage pipe through the levee, 16.5 feet below the crown. Flap gate is located on the waterside (WS) end. Manhole and grate are located on the landside (LS) toe. (30-inch pipe [HLM 0.01] authorized under Automatic Board Order (ABO) issued as Permit No. 10309, 1974 - City of Davis). [Additional Reference(s): DWR Levee Log, 1990. USACE Sacramento O&M Manual Unit 120, Willow Slough Channel Relocation and Levee Construction, February 1947, Drawing No. 50-4-2281 Sheet 4 (Station 270+70)] FS Date: 5/5/2015 8:02:49 AM

Waterside view- CMP grouted with concrete.

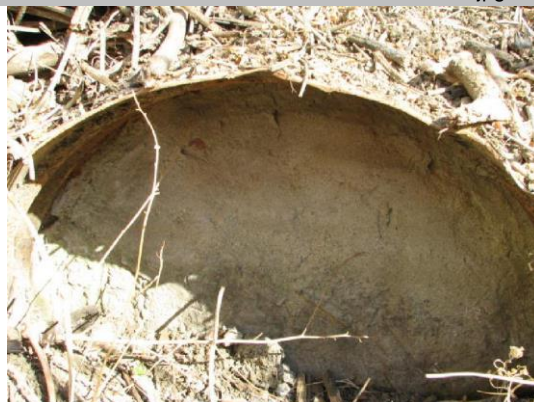
Photo 2 of 3 : UCIP_SP_2020_44904_22884.jpg

Waterside view- CMP grouted with concrete (closer view)

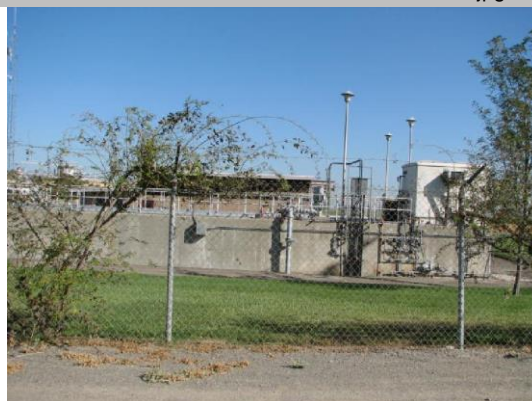
Photo 3 of 3 : UCIP_SP_2020_44904_22886.jpg

Landside overview- pumping plant not related with this crossing.

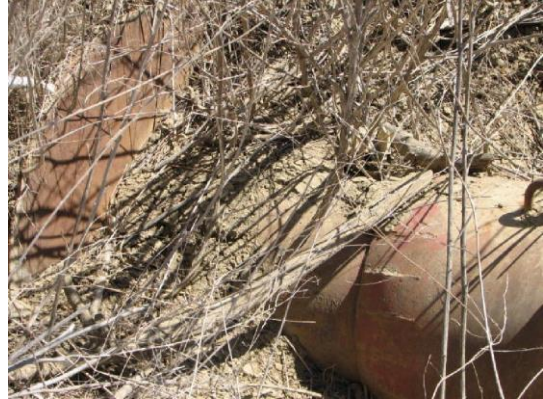
Photo 2 of 3 : UCIP_SP_2020_44929_22928.jpg

Waterside view- 20-inch pipe sleeved into 30-inch pipe

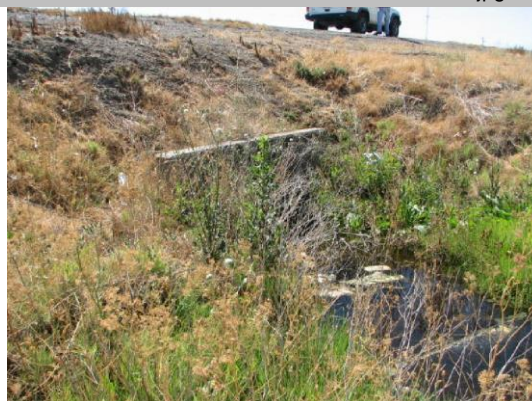
Photo 1 of 3 : UCIP_SP_2020_55422_22962.jpg

Comment Code						
Inspector Comment						
DS_ID:17620 FS_ID:55422 EP_NO: 10311 Repair Type: Non-Urgent Crossing Status: Found UCIP Comments: 11/01/2019 Received information from Vincent Rodriguez - FMO that this pipe was lined using the CIPP method on April 18, 2019. Removed Urgent status and will follow up with inspection photo. (O.Yakimov - DWR UCIP)04/09/2019 Grouted 10-foot into the pipe on the WS. Internal inspection has been completed and it shows major erosion of pipe. Recommend complete removal and replacement. Pipe is in a section of major county road (Road 29). (J. McCabe - DWR Sacramento Yard)04/12/2017 good/clear on LS & WS, inspected by JK, RF. (DWR Sacramento Yard - C. Lund) 05/28/2013 Some small vegetation removal is needed on landside of the levee. (DWR Sacramento - C. Lund) 09/19/2012 Vegetation removal on landside of the levee. (DWR UCIP - P. Amatya) FIELD_STRUCT_DESC: 24-inch corrugated metal drainage pipe through the levee, 10 feet below the crown. Flap gate is located on the waterside (WS) end. (24-inch pipe [HLM 2.95] authorized under Automatic Board Order (ABO) issued as Permit No. 10311 - Ittner and Harlan). [Additional Reference(s): DWR Levee Log, 1990. USACE Sacramento O&M Manual Unit 120, Willow Slough Channel Relocation and Levee Construction, February 1947, Drawing No. 50-4-2281 Sheet 1 (Station 118+00)] FS Date: 11/1/2019 8:16:07 AM

Landside view- inlet structure

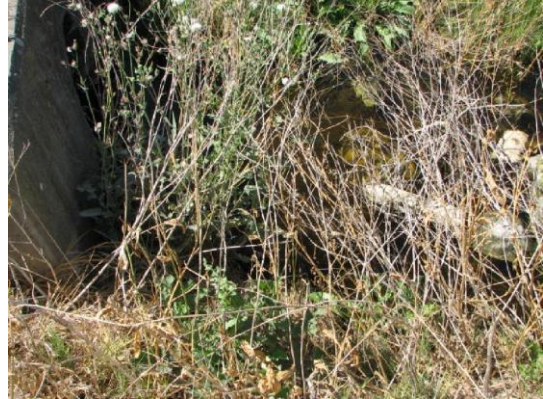
Photo 3 of 3 : UCIP_SP_2020_55422_22960.jpg

Landside view- vegetation around inlet.

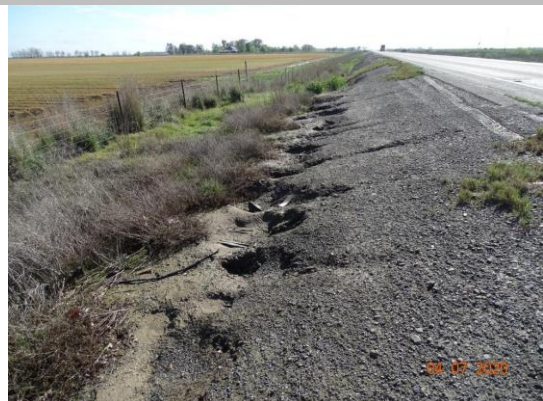
Photo 1 of 1 : SP_2020_ST0012_295_10_20200409_00036.jpg

LM Start	2.93	Rating **	M	Issue No.	10
LM End	3.00	Issue Type +	Ma	Location *	LS
Category	Earthen Levee			GPS Latitude/Longitude	
				Start	End
Item	Erosion / Bank Caving			38.590572 °	38.590653 °
				-121.719349 °	-121.720714 °
DWR ID	DWR_ST0012_01_s_2015_10				
Comment Code					
E1 : Note and monitor erosion site.					
Inspector Comment					
There appears to be runoff on the landside slope.

View of erosion on the landside slope. Spring 2020.

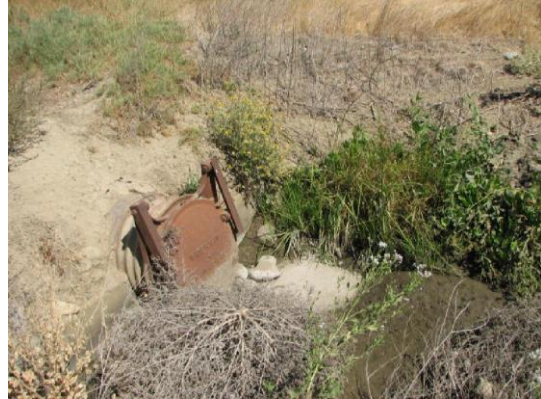
Photo 1 of 3 : UCIP_SP_2020_55421_22967.jpg

Comment Code						
Inspector Comment						
DS_ID:17621 FS_ID:55421 EP_NO: 10312 Repair Type: Non-Urgent Crossing Status: Found UCIP Comments: 11/01/2019 Received information from Vincent Rodriguez - FMO that this pipe was removed and replaced. Removed Urgent status and will follow up with inspection photo. (O.Yakimov - DWR UCIP)04/09/2019 Internal inspection has been completed and inspection shows major erosion on the WS outlet. Recommend complete removal and replacement. Pipe is in a section of major county road (Road 29). (J. McCabe - DWR Sacramento Yard) 04/12/2017 good/clear on LS & WS, inspected by JK, RF. (DWR Sacramento Yard - C. Lund) 09/19/2012 Depressions on waterside slope of the levee. (DWR UCIP - P. Amatya) FIELD_STRUCT_DESC: 24-inch corrugated metal drainage pipe through the levee, 10 feet below the crown. Flap gate is located on the waterside (WS) end. (24-inch pipe [HLM 3.08] authorized under Automatic Board Order (ABO) issued as Permit No. 10312, 1974 - Kelly). [Additional Reference(s): DWR Levee Log, 1990. USACE Sacramento O&M Manual Unit 120, Willow Slough Channel Relocation and Levee Construction, February 1947, Drawing No. 50-4-2281 Sheet 1 (Station 110+97)] FS Date: 11/1/2019 8:12:10 AM

Waterside view- pipe and flap gate.

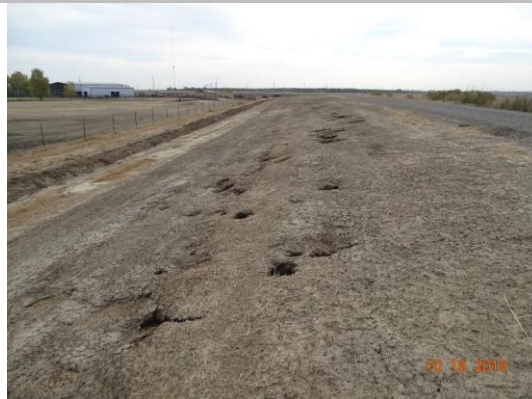
Photo 1 of 1 : SP_2020_ST0012_295_20_20200228_00007.jpg

LM Start	3.88	Rating **	M	Issue No.	20
LM End	3.92	Issue Type +	Ma	Location *	LS
Category	Earthen Levee		GPS Latitude/Longitude		
			Start	End	
Item	Slope Stability		38.593886 °	38.594355 °	
			-121.734986 °	-121.735409 °	
DWR ID	DWR_ST0012_01_f_2019_20				
Comment Code					
S1 : Repair slope instability.					
Inspector Comment					
Appears to be many sinkholes on the landside slope.

View of sinkholes on the landside slope. Fall 2019.

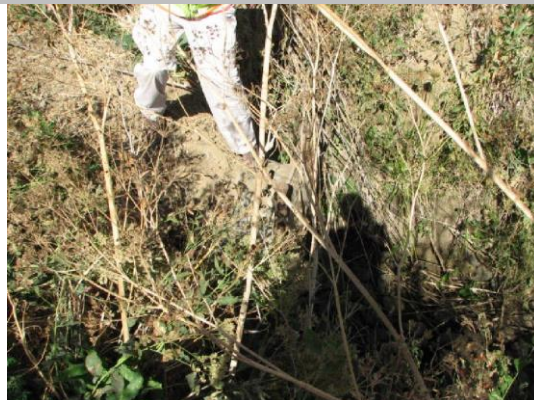
Photo 1 of 3 : UCIP_SP_2020_45286_22464.jpg

Comment Code					
Inspector Comment					
DS_ID:534 FS_ID:45286 EP_NO: 10327 Repair Type: No Action Needed Crossing Status: Found UCIP Comments: 04/12/2017 WS & LS - good/clear, inspected by JK, RF. (DWR Sacramento Yard - C. Lund) 05/24/2013 Flap gate repaired. (DWR Sacramento Yard - C. Lund) 09/20/2012 Flap gate is not properly closing. (DWR UCIP - P. Amatya) FIELD_STRUCT_DESC: 24-inch corrugated drainage pipe through the levee, 17.5 feet below the crown. Flap gate is located on the waterside (WS) slope. (24-inch pipe [HLM 0.78] authorized under Automatic Board Order (ABO) issued as Permit No. 10327 - Heidrick). [Additional Reference(s): DWR Levee Log, 1990. USACE Sacramento O&M Manual Unit 120, Willow Slough Channel Relocation and Levee Construction, February 1947, Drawing No. 50-4-2281 Sheet 1 (Station 47+00)] FS Date: 5/14/2015 1:36:52 PM

Waterside view- concrete headwall and CM pipe

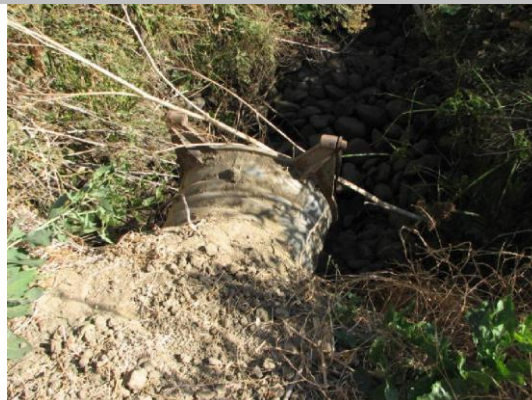
Photo 3 of 3 : UCIP_SP_2020_45286_22461.jpg

Waterside view- CM pipe and flap gate.

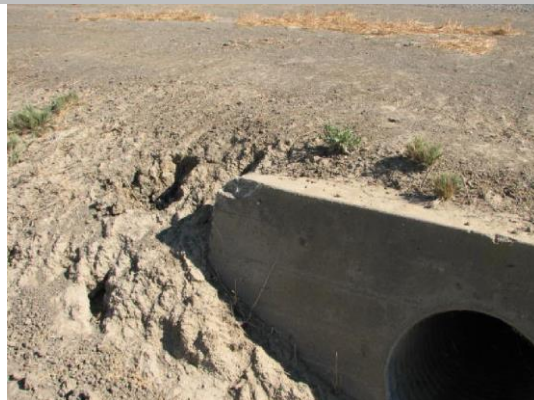
Photo 3 of 3 : UCIP_SP_2020_13725_22468.jpg

Landside view- concrete headwall corner chipped off

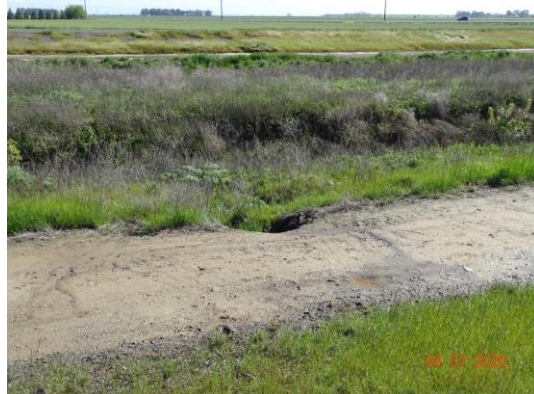
Photo 1 of 1 : SP_2020_ST0012_296_24_20200409_00050.jpg

LM Start	1.40	Rating **	A/W	Issue No.	24
LM End	1.40	Issue Type +	Ma	Location *	WS
Category	Earthen Levee			GPS Latitude/Longitude	
				Start	End
Item	Erosion / Bank Caving			38.591092 °	38.591092 °
				-121.733471 °	-121.733471 °
DWR ID	DWR_ST0012_02_f_2019_24				
Comment Code					
E1 : Note and monitor erosion site.					
Inspector Comment					
Erosion on the waterside slope and toe road. Recommend monitoring.

View of erosion within the waterside toe road. Spring 2020.

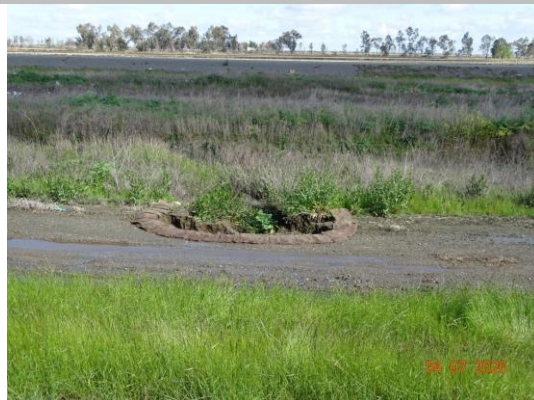
Photo 1 of 1 : SP_2020_ST0012_296_30_20200409_00053.jpg

LM Start	2.92	Rating **	M	Issue No.	30
LM End	2.92	Issue Type +	Ma	Location *	WS
Category	Earthen Levee			GPS Latitude/Longitude	
				Start	End
Item	Erosion / Bank Caving			38.589672 °	38.589672 °
				-121.705929 °	-121.705929 °
DWR ID	DWR_ST0012_02_s_2019_30				
Comment Code					
E2 : Schedule repair of erosion site prior to the next inspection.					
Inspector Comment					
There is erosion on the waterside toe road.

View of erosion within the waterside toe road. Spring 2020.

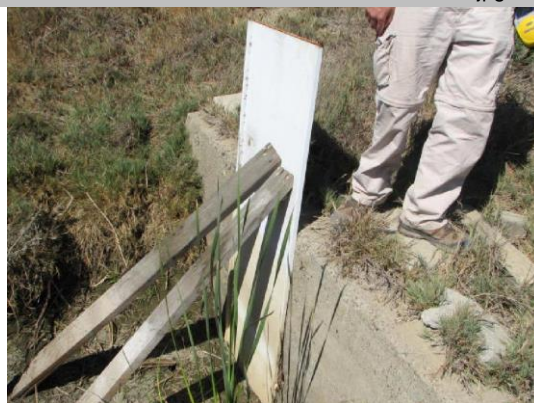
Photo 1 of 3 : UCIP_SP_2020_45291_22479.jpg

Comment Code					
Inspector Comment					
DS_ID:538 FS_ID:45291 EP_NO: 10328 Repair Type: No Action Needed Crossing Status: Found UCIP Comments: 04/12/2017 WS & LS - good/clear, inspected by JK, RF. (DWR Sacramento Yard - C. Lund) FIELD_STRUCT_DESC: 24-inch corrugated metal drainage pipe through the levee, 11 feet below the crown. Flap gate is located on the waterside (WS) end. (24-inch pipe [HLM 2.90] authorized under Automatic Board Order (ABO) issued as Permit No. 10328, 1974 - Heidrick). [Additional Reference(s): DWR Levee Log, 1990. USACE Sacramento O&M Manual Unit 120, Willow Slough Channel Relocation and Levee Construction, February 1947, Drawing No. 50-4-2281 Sheet 2 (Station 158+69)] FS Date: 5/14/2015 1:40:56 PM

Landside view- concrete headwall and pipe (temporarily closed used wooden planks).

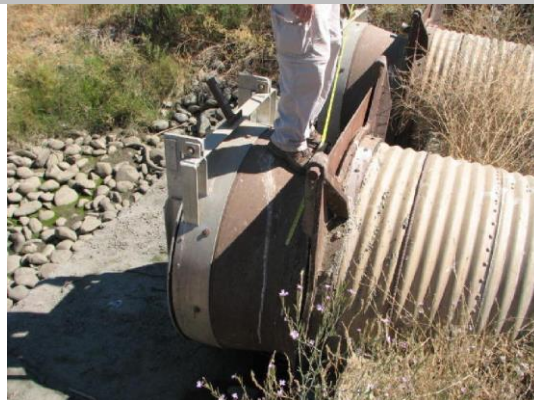
Photo 3 of 3 : UCIP_SP_2020_45294_22792.jpg

Comment Code					
Inspector Comment					
DS_ID:541 FS_ID:45294 EP_NO: 10335 Repair Type: No Action Needed Crossing Status: Found UCIP Comments: 09/20/2012 Landside view photos are missing. Daylight pipe is a steel pipe. The pipe through the levee may be a CMP. (DWR UCIP - P. Amatya) FIELD_STRUCT_DESC: 1 of 2. 42-inch corrugated metal drainage pipe through the levee, 12 feet below the crown. Flap gate located on the waterside (WS) end. 42-inch pipe sleeved through a 48-inch corrugated metal pipe (CMP). (two 48-inch pipes [HLM 3.54] authorized under Automatic Board Order (ABO) issued as Permit No. 10335, 1974 - Snyder). [Additional Reference(s): DWR Levee Log, 1990. USACE Sacramento O&M Manual Unit 120, Willow Slough Channel Relocation and Levee Construction, February 1947, (Station 192+80)] FS Date: 5/14/2015 1:41:55 PM

Waterside view- 42-inch steel pipe and flap gate.

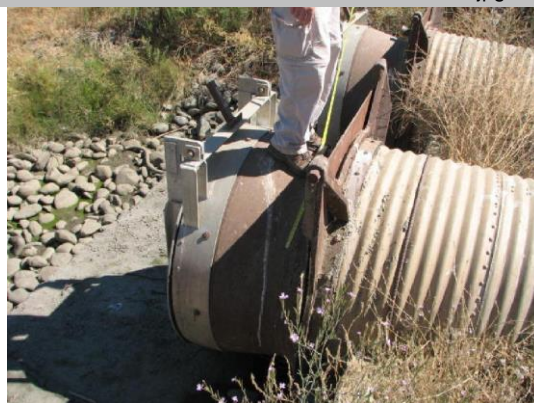
Photo 2 of 3 : UCIP_SP_2020_45295_22793.jpg

DS_ID:17729
 FS_ID:45295
 EP_NO: 10335
 Repair Type: No Action Needed
 Crossing Status: Found
 UCIP Comments: 05/05/2017 48-inch pipe authorized under ABO/Permit No. 10335. Reference has been verified and this crossing is referenced correctly. No records were found to support the additional of the 42-inch through the 48-inch pipe. (DWR UCIP - O. Magana) 09/20/2012 Daylight pipe looks like steel pipe. The pipe through the levee may be a CMP. Needs a landside view photos which is missing. This pipe may be a 42-inch pipe mentioned in ABO 10333. (DWR UCIP - P. Amaty)

Waterside view- 42-inch steel pipe and flap gate (right).

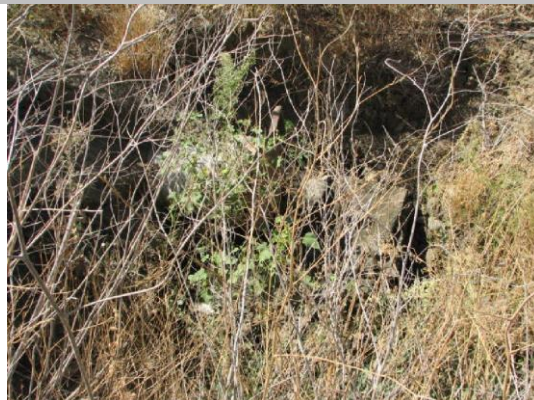
Photo 1 of 3 : UCIP_SP_2020_45298_22805.jpg

Waterside overview- pipe and flap gate with dense vegetation.

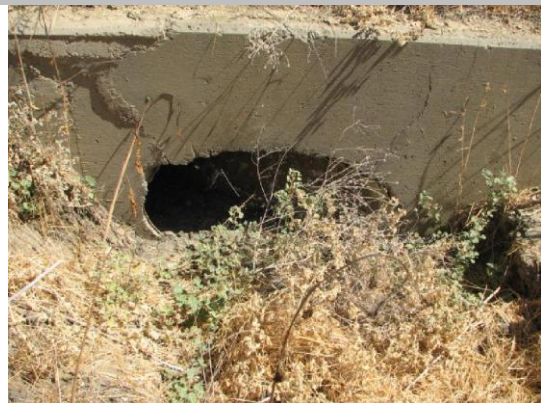
Photo 3 of 3 : UCIP_SP_2020_45285_22810.jpg

Landside view- soil and debris on mouth of the inlet pipe.

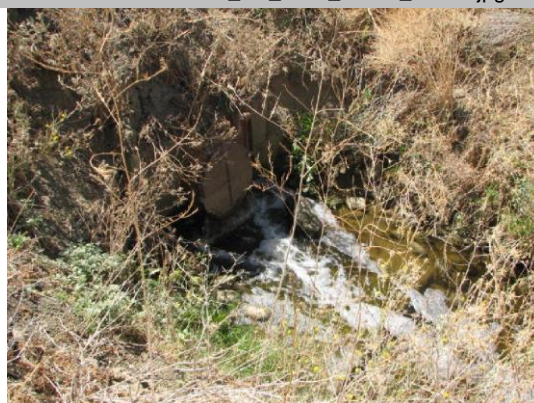
Photo 3 of 3 : UCIP_SP_2020_45301_22846.jpg

Waterside view- pipe and flap gate. Water was running in the pipe during the survey.

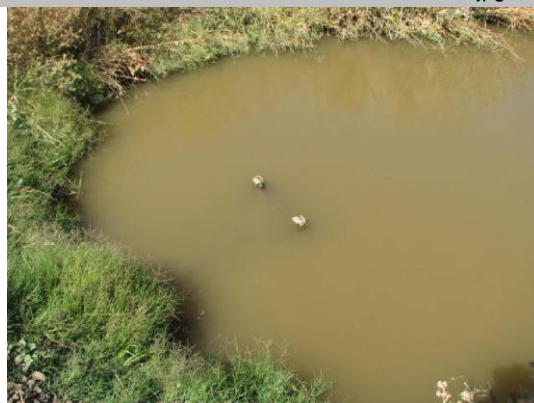
Photo 2 of 3 : UCIP_SP_2020_45307_22868.jpg

Waterside view- outlet structure under the water.
